9.1 Introduction

9.2 Experimental procedures

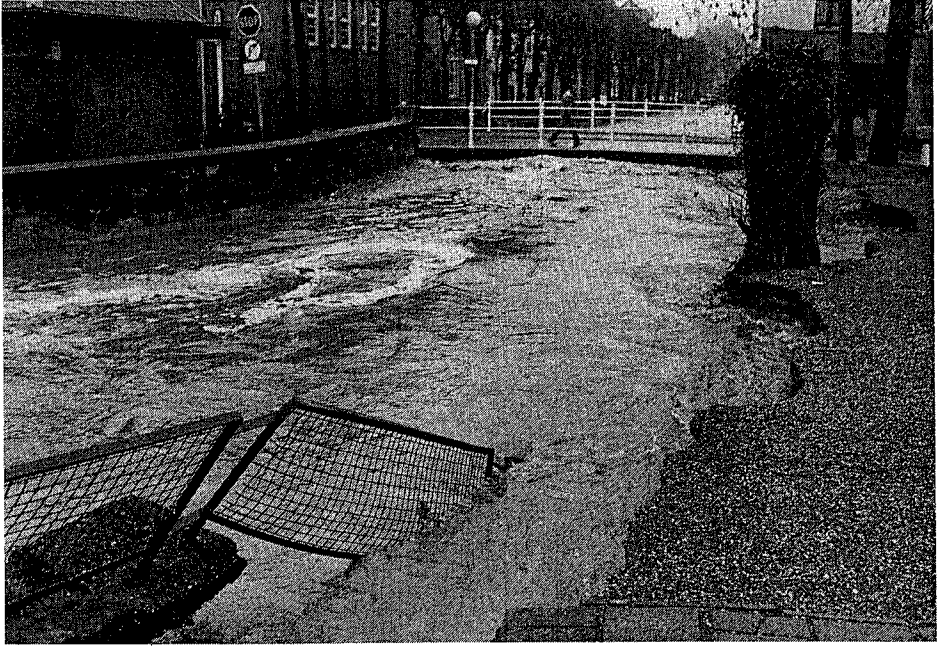
Photo 9.1 Collapsing river banks during a flood in the village of Valkenburg.

It has been noted that during the last two decades there is a rapid increase in the local erosion of the streambanks of the Geul. In the urban areas, the channel migrations cause serious damage to sheet-pilings and buildings on the river banks. Photos 9.1 and 9.2 show the effects of a major flood in February 1987 in the village of Valkenburg: the water level reached as high as the small bridge and the river banks collapsed a few hours before the flood peak (Photo 9.1),

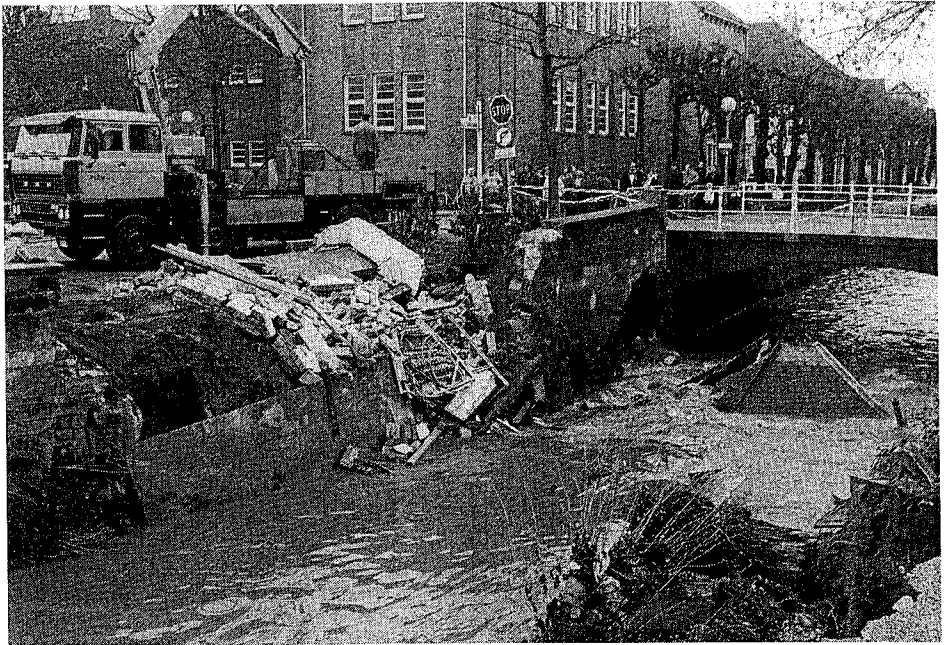
Photo 9.2 A few hours after the flood peak at the same location as on Photo 9.1: the electricity station and the sheet-pilings are devastated.

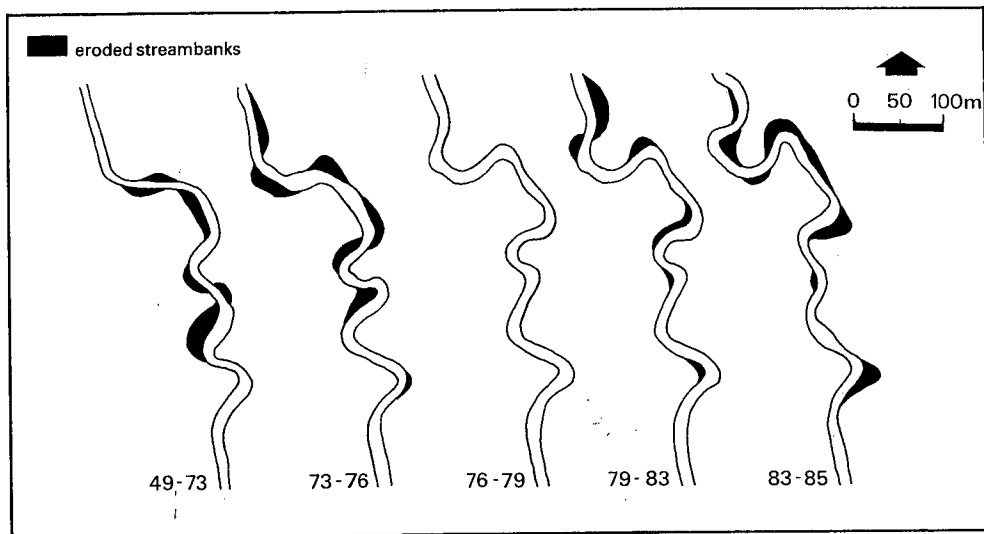
Figure 9.2 River channel changes of the Geul near Partij.

which had a devastating effect on the sheet-pilings and the electricity station (Figure 9.2). Inspection of a sequence of aerial photographs of a small section of the river channel located in the rural area near Partij (see Figure 2.1), revealed that the local rate of channel migration may be as high as 5 meters/year (see Figure 9.2). Moreover, in a number of recent 3-4 year periods (1973-'76, 1979-'83 and 1983-'85) the channel displacement is of the same order of magnitude as in the 24 year period 1949-'73. No major storms occurred in the period 1973-'76 and no channel displacements could be seen on the photographs.
